Akutan Harbor Project: Delineation of Wetlands on Akutan Island, Alaska

by James S. Wakeley, Chris V. Noble, and Michael J. Bishop

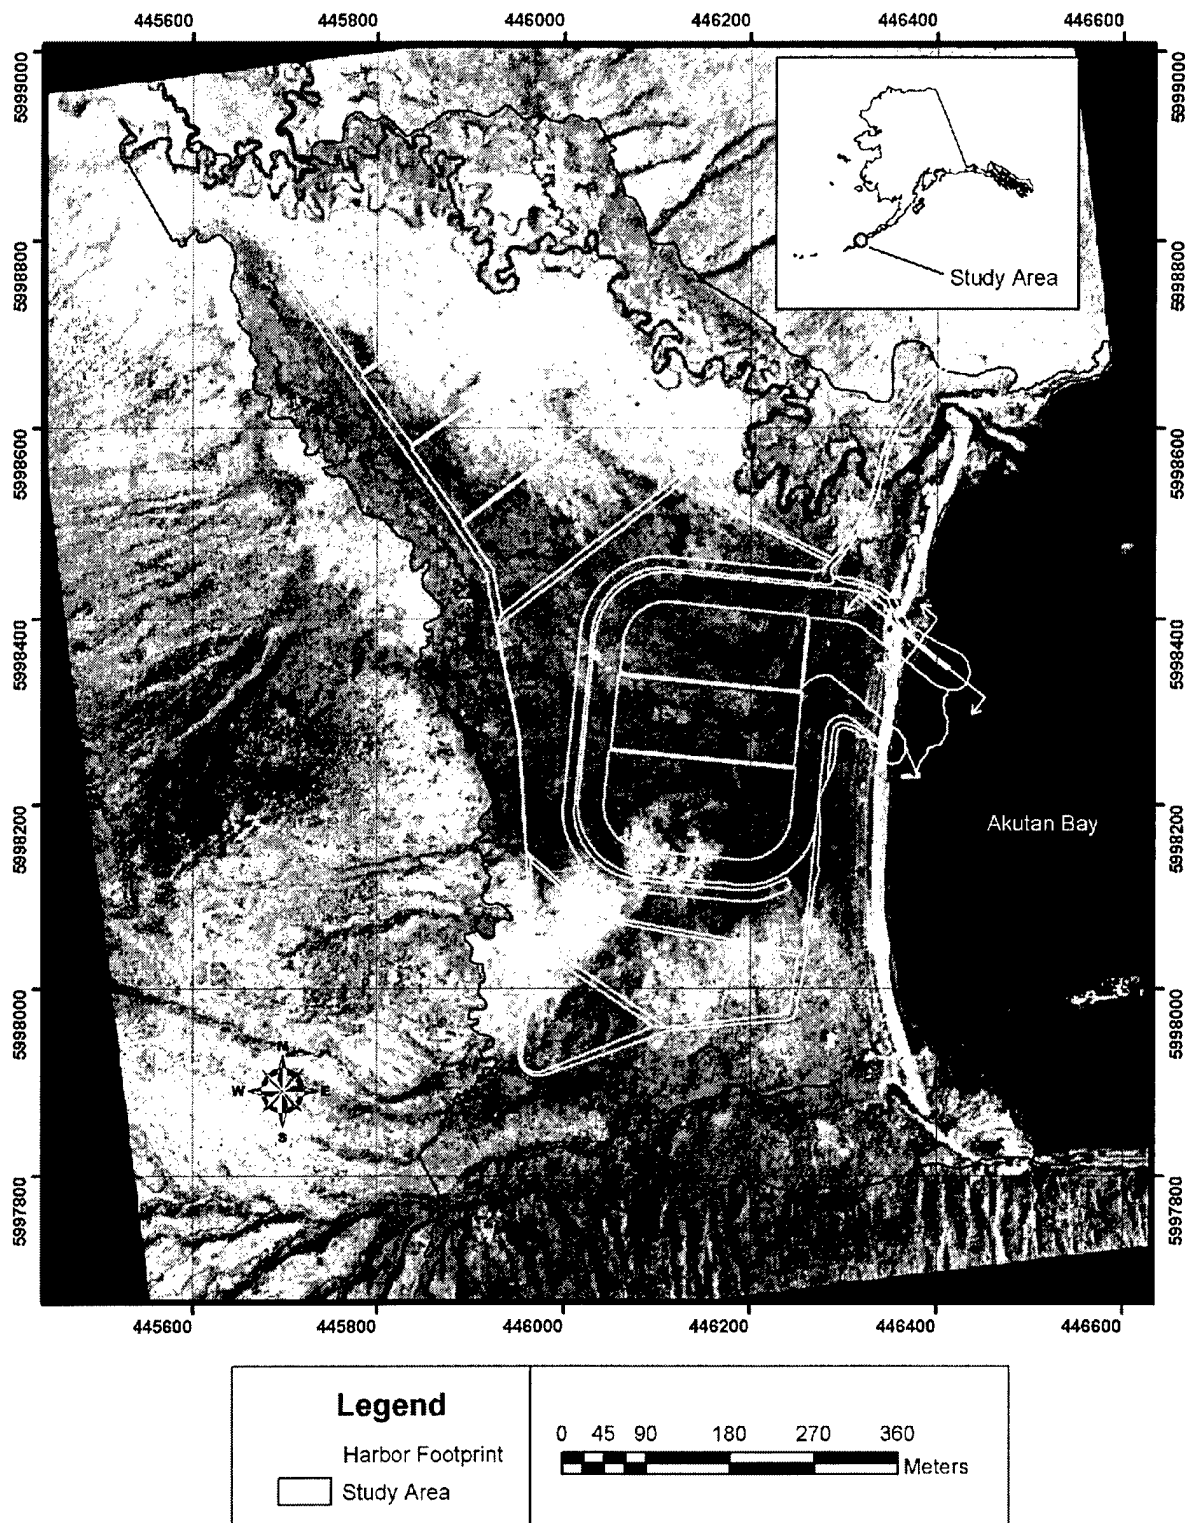
Figure 1. Study area at the western end of Akutan Bay, Akutan Island, Alaska, with the current design for Akutan Harbor and its associated fill area superimposed. Coordinates are based on 200-m Universal Transverse Mercator (UTM) grid ticks. The background photographic image was provided by AeroMap US, Anchorage, AK, and the harbor design by Tryck, Nyman, and Hayes, Inc., Anchorage

At the time the field work was done in August 2000, three project alternatives had been proposed, differing in basin size (12, 15, or 20 acres [4.9, 6.1, or 8.1 ha]) and in the extent of filling for berms and graded areas. In all three plans, the harbor basin would be excavated behind the existing natural beach ridge and would open to the sea by an excavated channel roughly through the middle of that ridge. All three designs included an access road from the north. Later, in April 2001, a modified 12-acre-basin alternative was proposed, which took advantage of detailed topographic data gathered during the field studies. Figure 1 shows the outline of this alternative, which included approximately 55 acres (22 ha) of associated fill.

There were 58 acres (23.5 ha) of wetlands within the footprint of the most recently proposed design for Akutan Harbor and its associated fill area (Figure 1). Placing the proposed harbor in the approximate center of the alluvial plain would result in a considerable impact to the surrounding wetlands. One option to reduce wetland impacts, and perhaps lessen the threat to the north creek complex and its salmon runs, would be to shift the project toward the south and take advantage of upland areas there, particularly to the southeast.

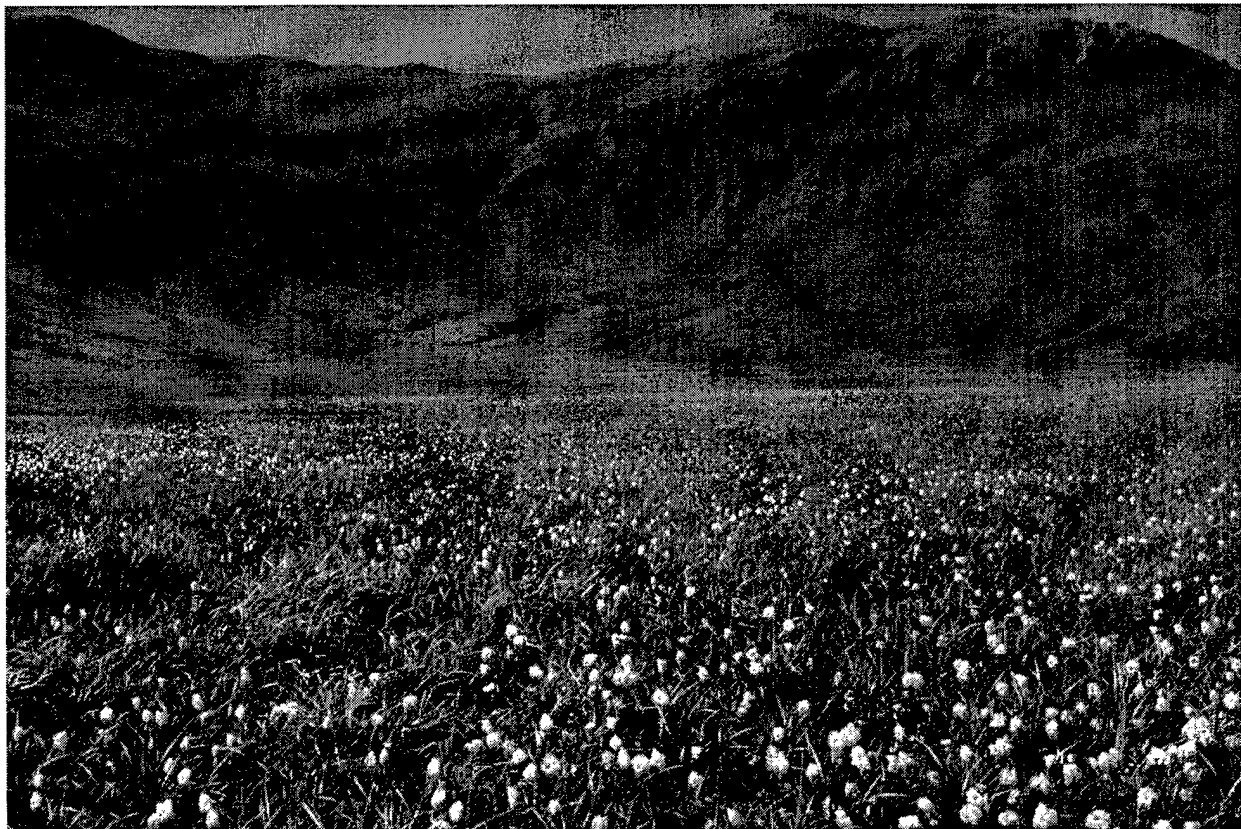
Figure 3. Sedge-dominated community containing cotton-grass as a subdominant

Sedge-dominated communities (Figure 3) ranged from pure stands of Lyngbye's sedge (*Carex lyngbyei*) (OBL) in areas that contained standing water during the site visit to diverse communities of sedges, grasses, broad-leaf herbs, and low shrubs on somewhat drier sites. Depending upon the location, dominant species included Lyngbye's sedge, several-flowered sedge (*C. pluriflora*) (OBL), chestnut rush (*Juncus castaneus*) (FACW), common marsh-marigold (*Caltha palustris*) (OBL), meadow horsetail (*Equisetum pratense*) (FACW), black crowberry (*Empetrum nigrum*) (FAC), hooded ladies'-tresses (*Spiranthes romanzoffiana*) (OBL), seawatch angelica (*Angelica lucida*) (FACU), under-green willow (*Salix commutata*) (FAC) and others. Narrow-leaf and russet cotton-grasses (*Eriophorum angustifolium* [OBL] and *E. chamissonis* [OBL]) were showy subdominants in many sedge-dominated areas.

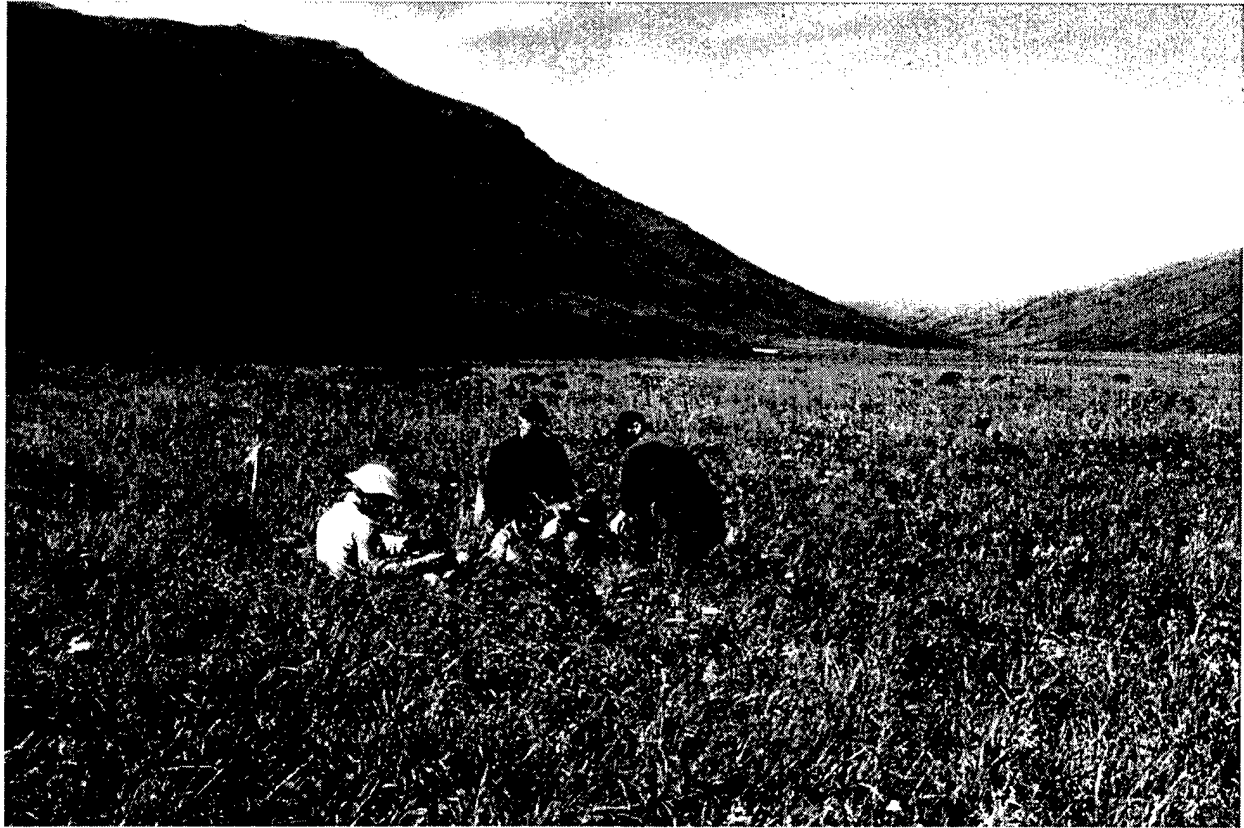
Figure 4. Grass-dominated community

Grass-dominated communities (Figure 4) generally occupied topographically higher and somewhat drier sites than the sedge-dominated communities, but many of the grass-dominated areas still met all three wetland criteria. The predominant grasses were blue-joint reedgrass (*Calamagrostis canadensis*) (FAC) and tufted hairgrass (*Deschampsia cespitosa*) (FAC). Another grass species was dominant at several sampling points but could not be identified due to the lack of an inflorescence at the time of sampling. Other dominant plants in grass-dominated wetland communities included

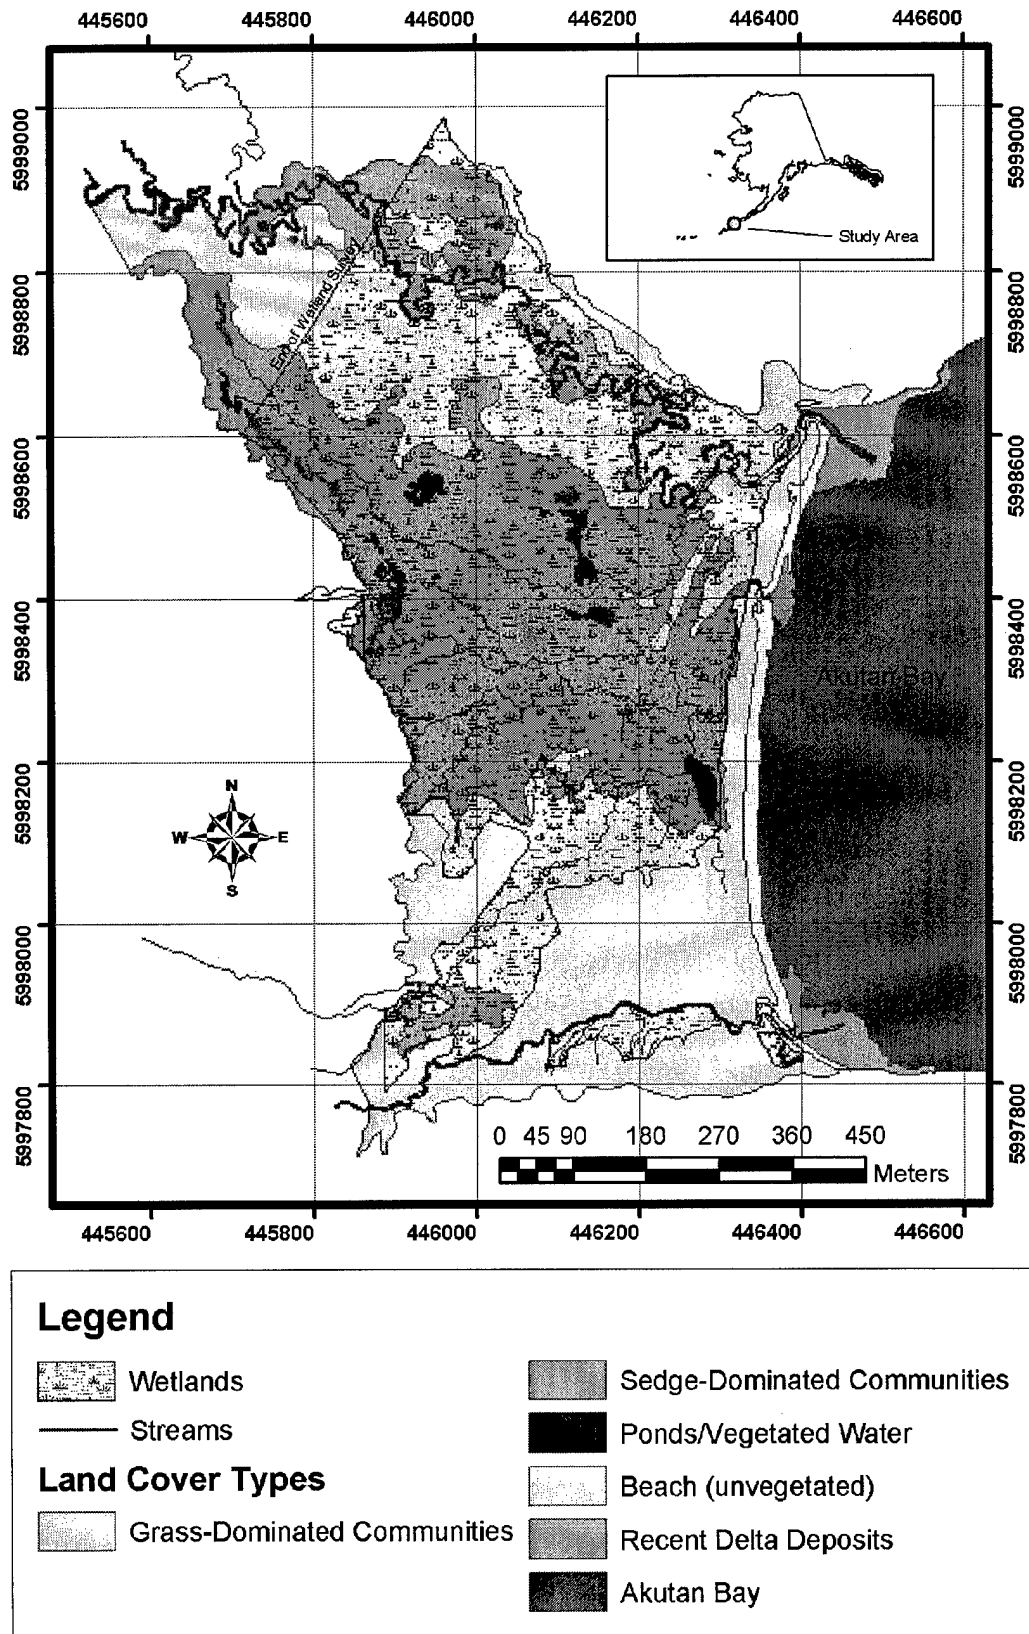
Figure 5. Land cover and wetland boundaries on the Akutan Harbor Project site

WETLAND BOUNDARIES: In general, one vast wetland complex extended from the base of the northern hills, southward across the entire alluvial plain between the bases of the beach ridge on the east and the hill slopes to the west (Figure 5). Occasional seep wetlands extended up the lower slopes of both the northern and western hills. In the southeastern direction, the wetland ended in gradually rising terrain near the site of an old homestead. To the southwest, a wetland corridor extended toward the upper reaches of the south creek. In addition, isolated wetlands were identified near the mouths of both the north and south creeks, and along the right descending bank of the south creek.

CONCLUSIONS: Approximately 95 acres (38 ha) of wetlands were identified in the study area (Figure 5) including virtually all of the sedge-dominated plant communities and the wetter portions of the grass-dominated areas. Nearly all of the northern portion of the study area was wetland, and wetlands continued up the north creek drainage beyond the end of the wetland survey area. In the southern portion of the study area, wetlands were somewhat less extensive, being more or less restricted to a broad drainageway toward the southwest and some isolated wetland patches on the south side of the south creek.
